PRELIMINARY SITE INSPECTION REPORT

Resource Recovery Corporation TDD R10-8408-22

Resource Recovery Corporation Pasco Sanitary Landfill Kahlotus Road and Highway 12 Pasco, WA 99301

9/12/84 0800 hrs.

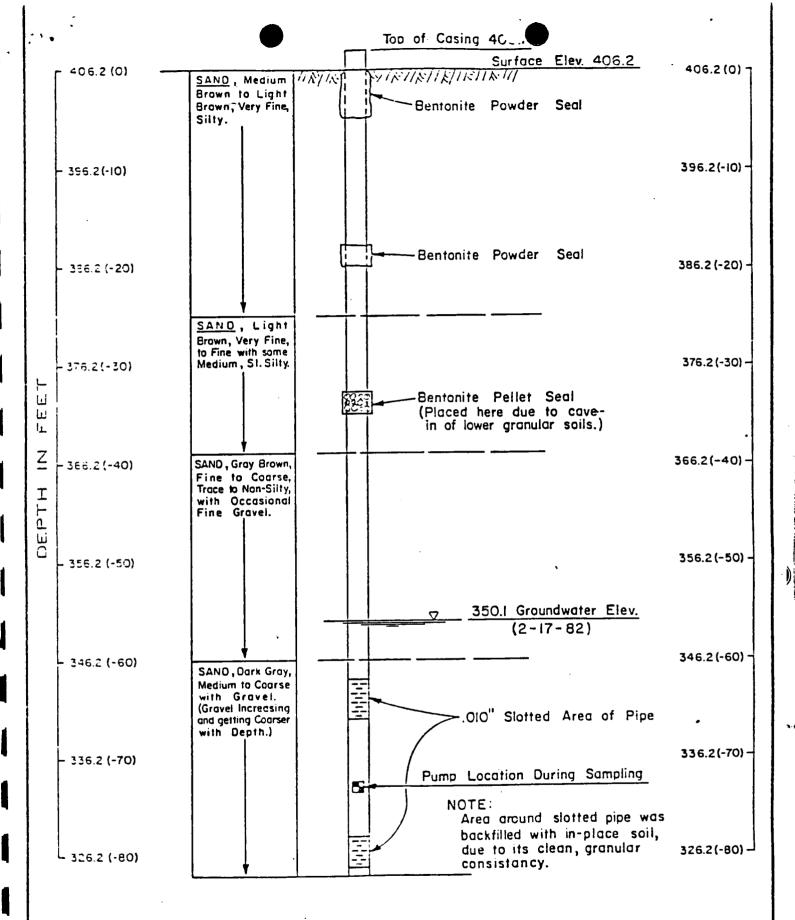
FIGURE 7.1
WELL NO. 2 (5)
INSTALLED I-14-82

One factor that may efect the quality of analytical data of the groundwater samples collected from the PSL is the monitoring well design (Figure 7.1). The wells are screened at 2 intervals separated by approximately 15 feet. The water samples are obtained by placing a

pump halfway between these screens. Utilizing this design there is no assurance that:

- o equal amounts of water are extracted from each screened interval;
- o the depth from which the sample is being collected is accurately known;
- o the concentrations of contaminates are representative of the actual groundwater conditions due to the potential unequal volumes of water are extracted from each screened interval.
